*JMS III, LLC*  
**TIRE ENGINEERING & TIRE FAILURE ANALYSIS**

**RE: GOODEN/CUBILLOS vs FEDEX, et al.**  
**JMS III FILE NO. 15-032**

An accident occurred when the left front tire failed on a 2011 Freightliner tractor pulling two trailers driven by Brian Kehler and the truck veered left across the center divider and collided with other vehicles.

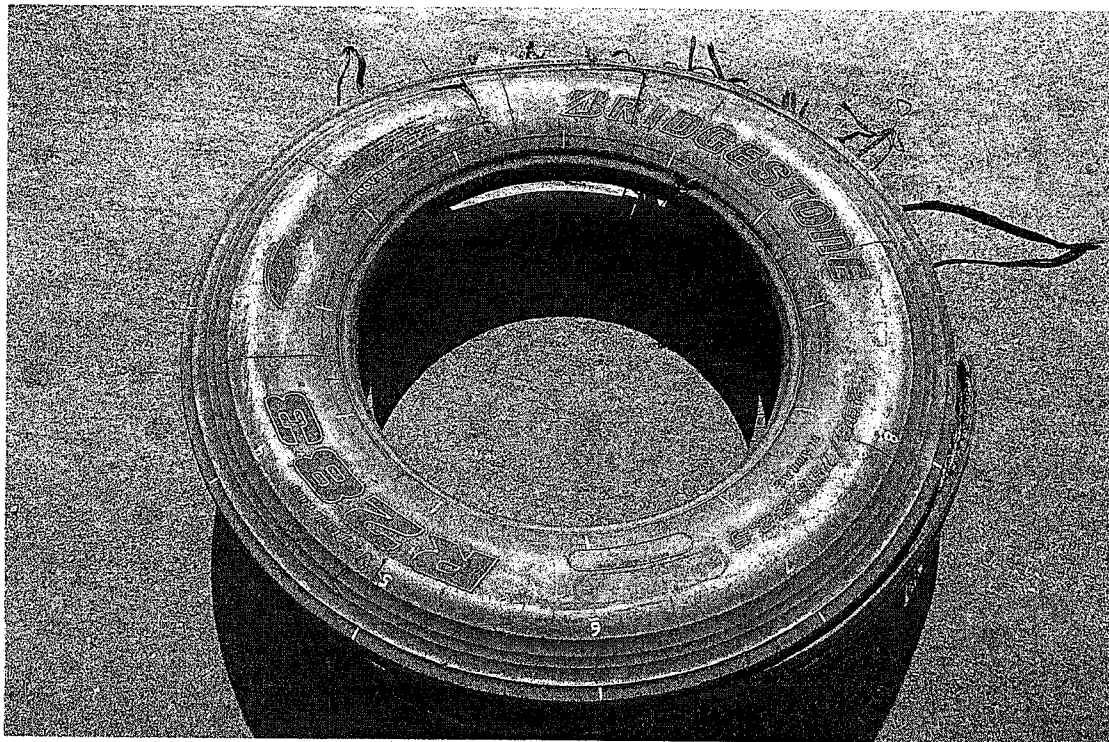
Figure 1 is a view of the serial sidewall of the tire casing and Figure 2 is a closer view of the serial side bead with a pattern that was transferred to the tire from the aluminum rim. The pattern reflects wear that occurred to the rim during the more than ½ million miles it was used with numerous various tires. Figure 3 is a view of the nonserial sidewall of the tire casing and Figure 4 is a closer view of the nonserial side bead with a somewhat different wear pattern transferred from the other side of the aluminum rim.

In their reports, Brian Queiser, Joseph Grant and John Smith identified rim compression grooves as evidence of underinflated operation. However, the marks on the tire beads, Figures 2 and 4, lacked any significant depth and were simply impressions of the worn, eroded surface of the alloy rim flanges, the result of wear that occurred during the more than ½ million miles the rim had been used. The squared edges of the tread shoulder ribs, Figures 8 and 10, and the overall even treadwear, Figure 9, along with the lack of sidewall scuffing, Figures 1 and 3, or innerliner abrasions, Figures 5 and 6, indicated that the tire was not run overdeflected.

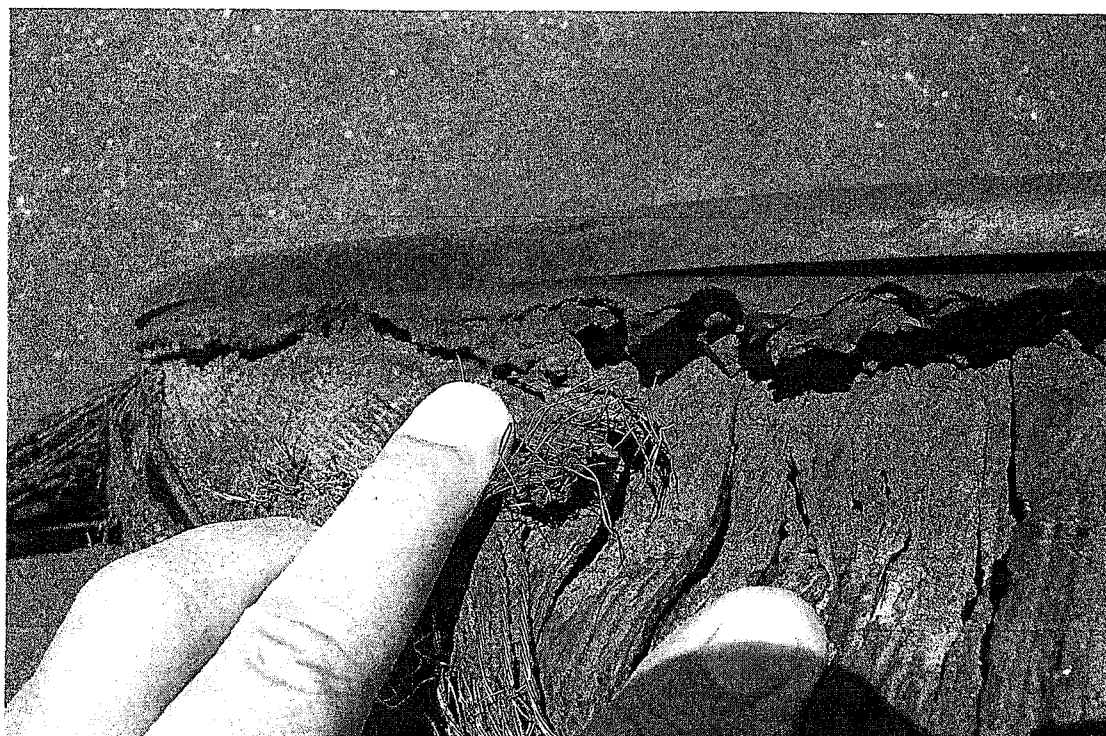
Figure 11 shows a localized area of the nonserial side tread shoulder where the outermost groove was worn completely away, indicated by the arrow near the center of the photograph. The groove can be seen on either side of the worn area, in Figure 11 and Figure 12, where it was approximately 6/32nds of an inch deep. Localized wear patterns such as this are caused when a long term internal separation, typically between the belts, allows the tread to squirm as it goes through the footprint; this squirming causes faster wear to the tread in the area above the separation. As the tire continues to be used, the separation will grow circumferentially and across the tread. Figure 13 shows polishing on top of the #2 belt where the separation extended to approximately 275 degrees on the nonserial shoulder. Figure 14 shows the underside of the separate tread piece where the separation between the #2 and #3 belts had expanded to within about 2 inches of the serial side shoulder and to about 30 degrees along the nonserial shoulder.

The subject tire failed as the direct result of a localized separation between the #2 and #3 belts which initiated in the area of 315 degrees closer to the nonserial shoulder. The separation was present in the tire for many miles, based on the accelerated wear shown in Figures 11 and 12. The separation propagated until it had grown to extend along the nonserial shoulder from about 275 degrees to 30 degrees and across the crown of the tire to within a couple inches of the serial shoulder. As the separation grew, the weight of the separated tread and belts increased until the forces generated as the tire rotated were sufficient to tear the separated piece from the tire casing. Without the support of the tread and belt package, the radial casing cords spread and rapid air loss occurred.
